Monitoring Data Record

Project Title: R-2552B Clayton Bypass COE Action ID: 200220745
Stream Name: UT to Little Creek (Site 5) DWQ Number: 041760
City, County and other Location Information: US 70 Clayton Bypass from I-40 to US 70
Station 82+60 to 85+50 -L-
Date Construction Completed: 4/21/06
Monitoring Year: (5) of 5
Ecoregion: _____ 8 digit HUC unit 03020201
USGS Quad Name and Coordinates: _____

R-2552B Clayton Bypass

Year 5 Summer – August 2011

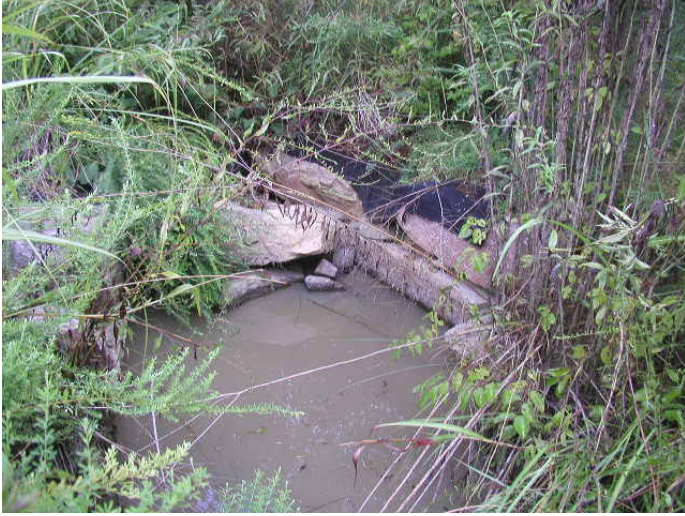
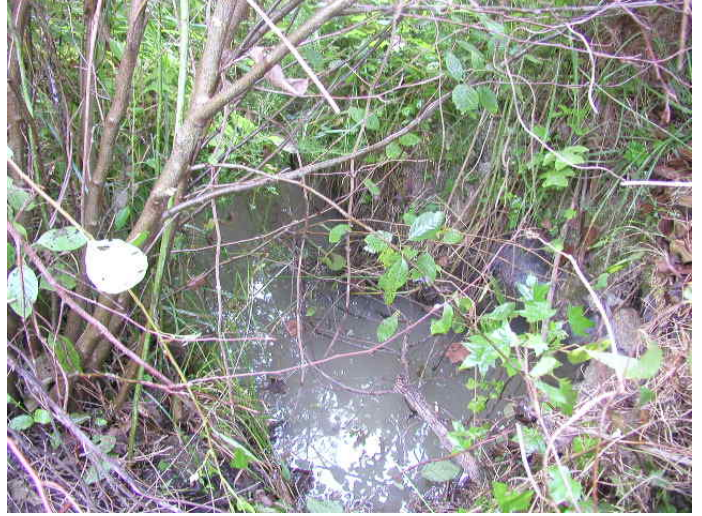
Photo Point #4 (Upstream)

The stream relocation is stabilized for the Year 5 Summer evaluation. There was some minor bank scouring noted along the right bank at Sta. 11+05-S- but overall the channel is highly stabilized with extensive growth of vegetation in and around the channel. NCDOT proposes to discontinue channel stability monitoring.

8/4/11	STA. 11+05-S- @ Photo Point #4	Station Number	Station Number	Station Number	Station Number
Structure Type					
Is water piping through or around structure?					
Head cut or down cut present?					
Bank or scour erosion present?	Minor bank scouring along right bank				
Other problems noted?
